DYNA SCAN  
Technical Services

## Infrared Thermographic Inspection

**Current Inspection No: 4571**  
**Report Date: 8/18/2018**  
**Inspected By : Fitzpatrick, Mike**

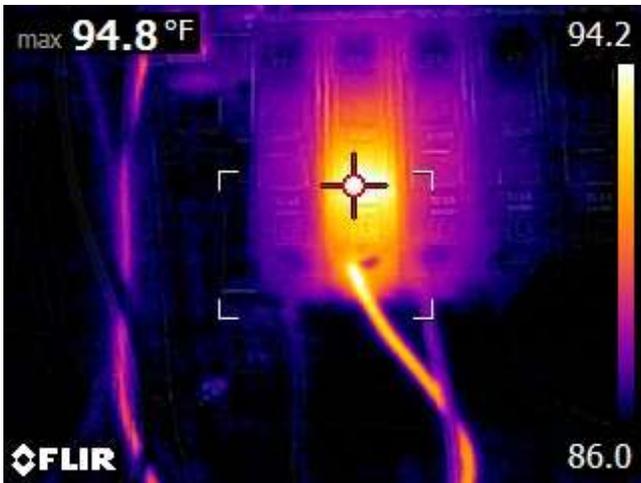
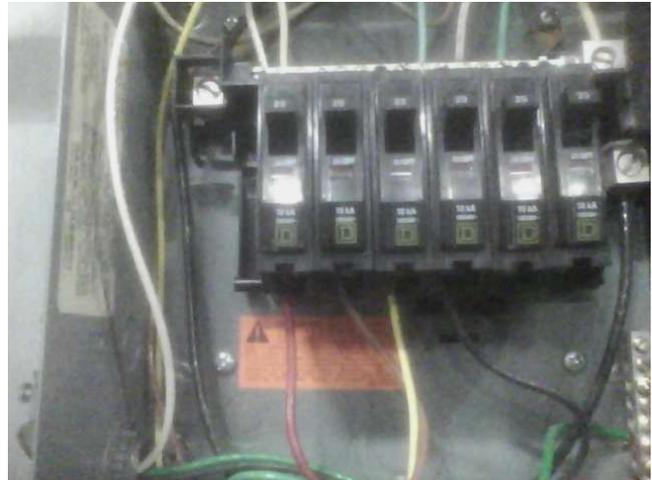
**Location: Main Floor Perimeter  
#3**

Target Point	Reference Point	Temperature Difference	Severity: 4-Minor
Breaker #2: 95 F	Breaker #1: 92 F	3 F

Target is breaker #2. Overload on breaker. Amp draw between 13 and 18.

Further investigation is required to determine the correct repair procedure.

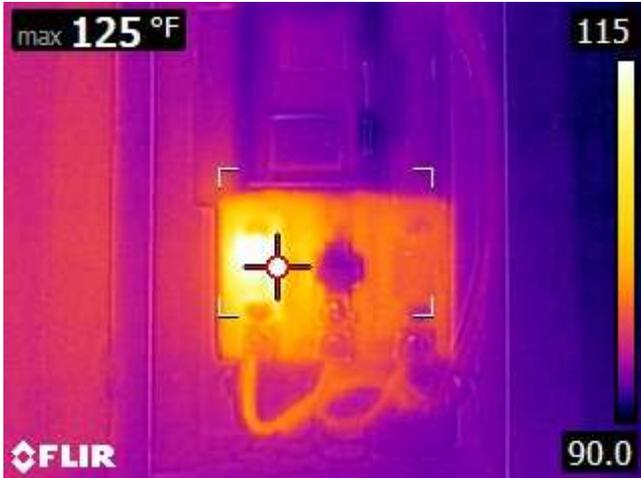
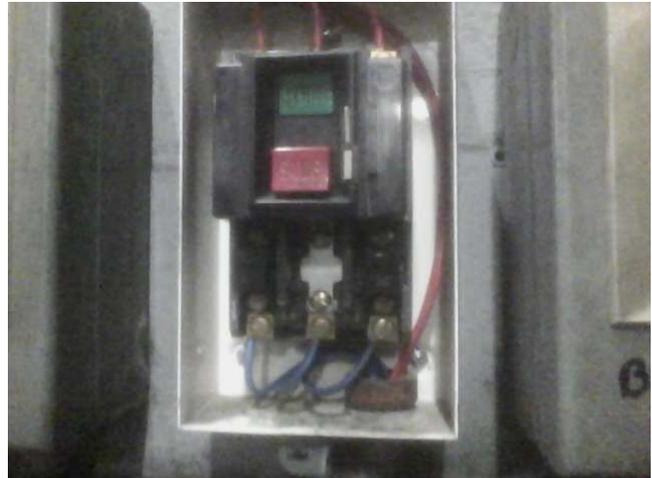
**Location: Main Floor Perimeter  
F4**

Target Point	Reference Point	Temperature Difference	Severity: 3-Important
(A) Phase: 125 F	(C) Phase: 92 F	33 F

Target is the (A) phase contact on starter.

Due to age and condition of target, recommend replacing

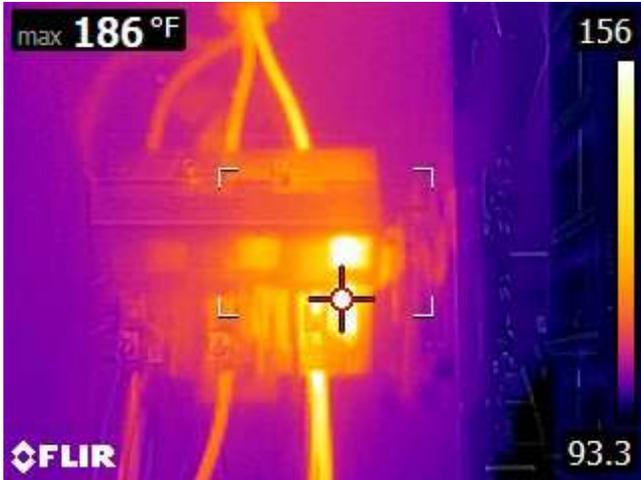
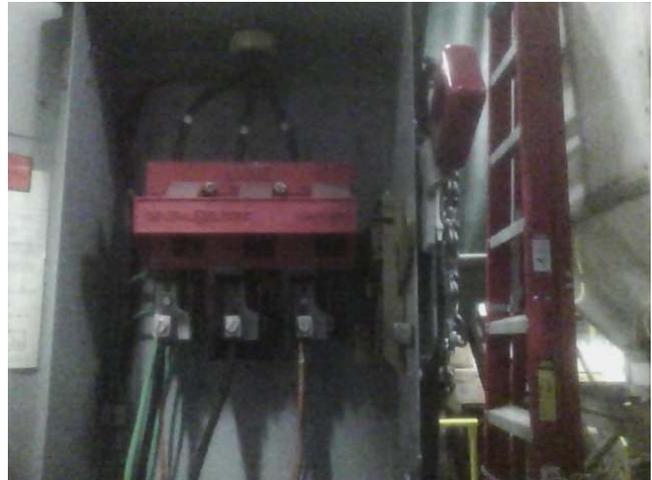
**Location:** Main Center Machine Line  
**PRESS 2**

Target Point	Reference Point	Temperature Difference	Severity: 1-Critical
(C) Phase: 186 F	(A) Phase: 111 F	75 F

Target is the (C) phase knife switch on disconnect. Staff notified.

Shut off power to assembly and inspect knife switch for proper blade tension and alignment. Clean blades thoroughly. Repair or replace parts as necessary.

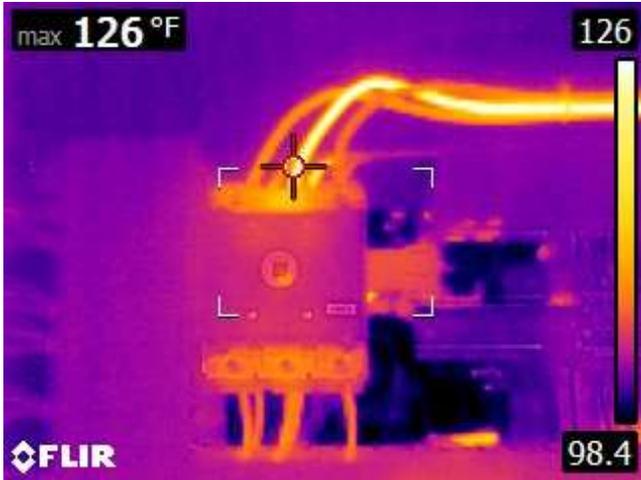
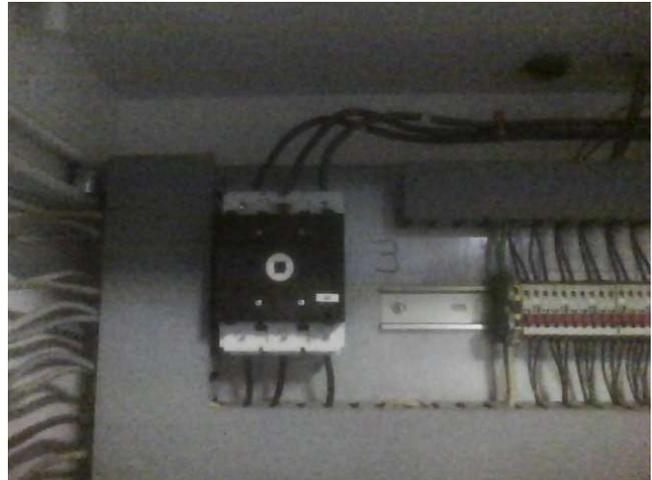
**Location:** Main Center Machine Line  
**PRESS 3**

Target Point	Reference Point	Temperature Difference	Severity: 3-Important
(B) Phase: 126 F	(A) Phase: 108 F	18 F

Target is the (B) phase wire connection on disconnect. Visual heat damage.

Check lug connection.

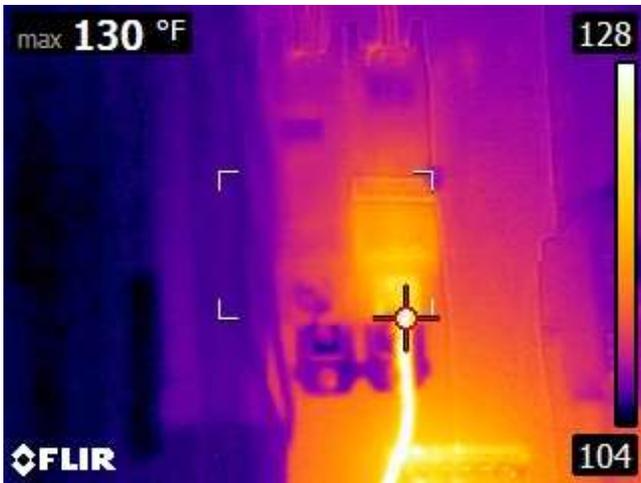
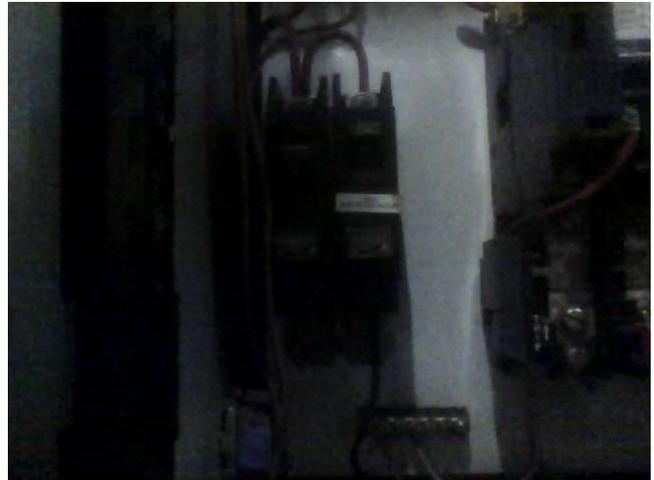
**Location: Main Center Machine Line  
E8**

Target Point	Reference Point	Temperature Difference	Severity: 3-Important
Load Side: 130 F	Line Side: 110 F	20 F

Target is the load side Lug connection on breaker.

Check lug connection.

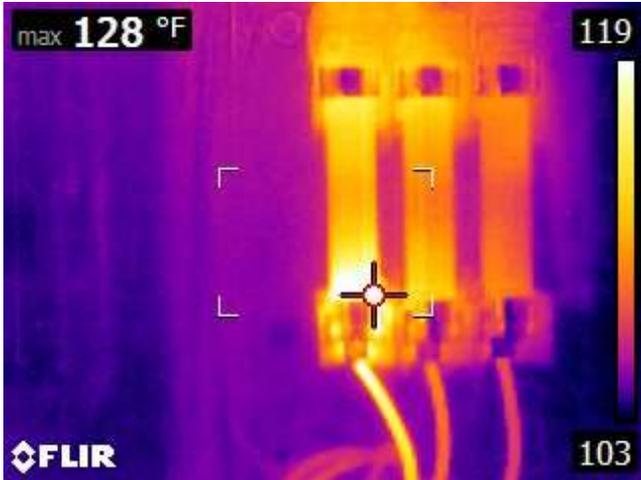
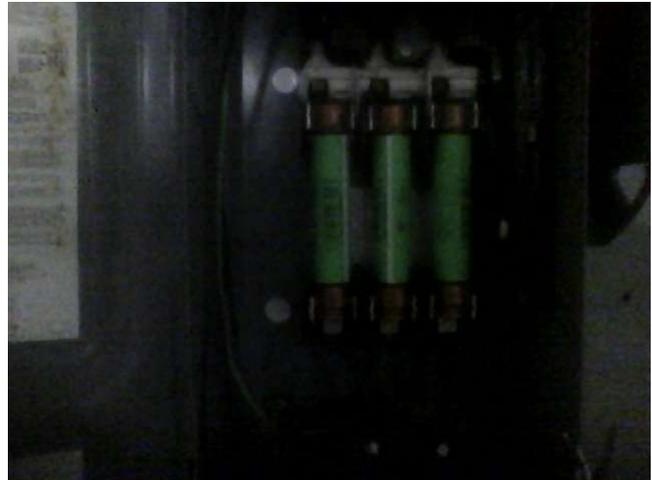
**Location:** Main Center Machine Line  
E6

Target Point	Reference Point	Temperature Difference	Severity: 3-Important
(A) Phase: 128 F	(C) Phase: 110 F	18 F

Target is the (A) phase fuse clip on disconnect.

Shut off power to disconnect and remove the a-phase fuse. Clean fuse and fuse clips. Inspect fuse clips for proper tension and repair or replace parts as necessary. Upon completion, rescan target area with heat gun.

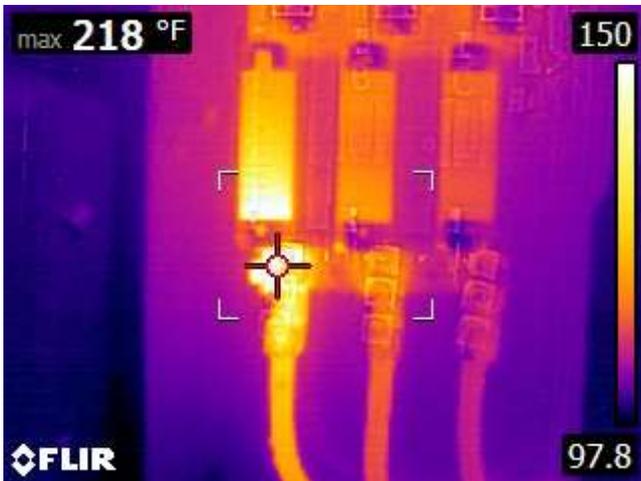
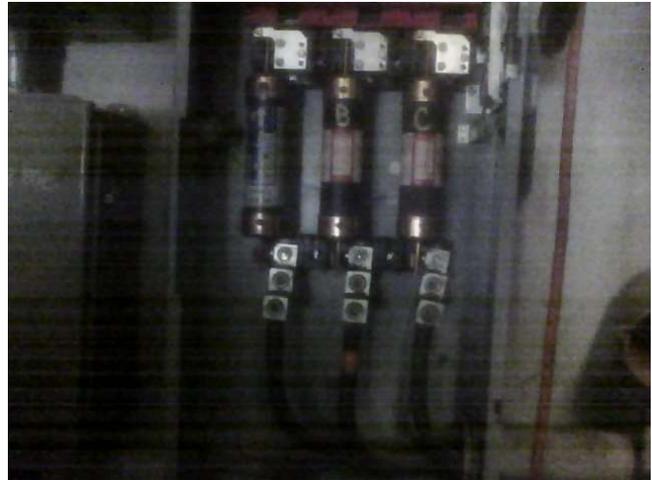
**Location:** Old Basement  
**WATER SYSTEM MAIN**

Target Point	Reference Point	Temperature Difference	Severity: 1-Critical
(A) Phase: 218 F	(C) Phase: 109 F	109 F

Target is the (A) phase fuse clip on disconnect. Staff notified.

Shut off power to disconnect and remove the a-phase fuse. Clean fuse and fuse clips. Inspect fuse clips for proper tension and repair or replace parts as necessary. Upon completion, rescan target area with heat gun.

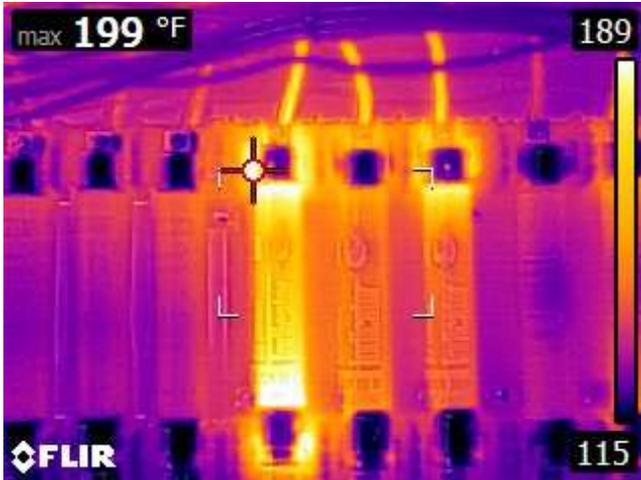
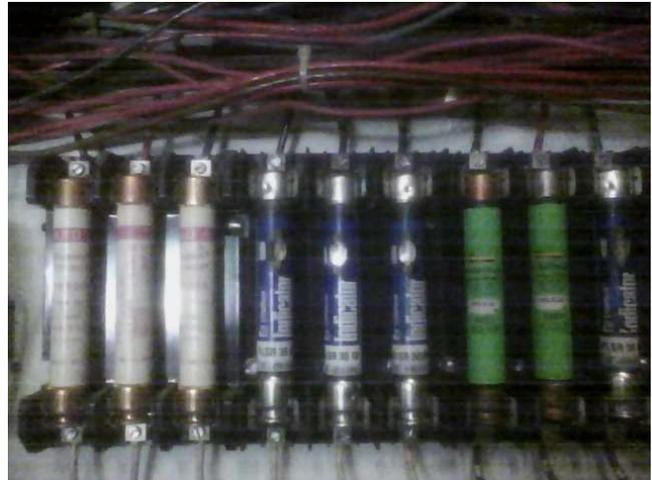
**Location:** Old Basement  
**WATER SYSTEM MAIN**

Target Point	Reference Point	Temperature Difference	Severity: 1-Critical
(A) Phase: 199 F	(B) Phase: 116 F	83 F

Target is the (A) phase fuse clip on fuse block. Check the (C) phase clip also. Staff notified.

Shut off power to disconnect and remove the a-phase fuse. Clean fuse and fuse clips. Inspect fuse clips for proper tension and repair or replace parts as necessary. Upon completion, rescan target area with heat gun.

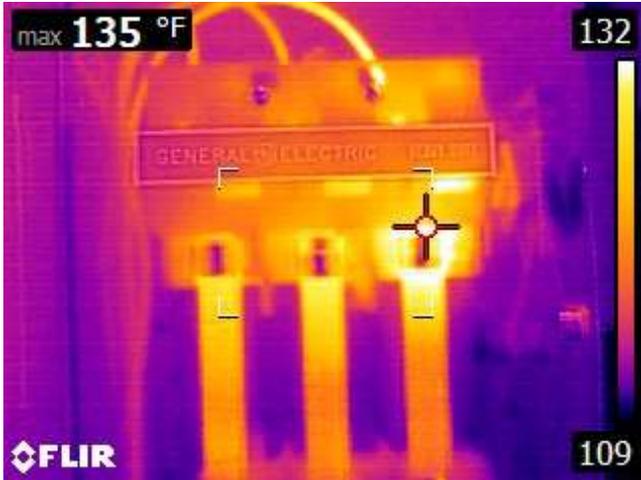
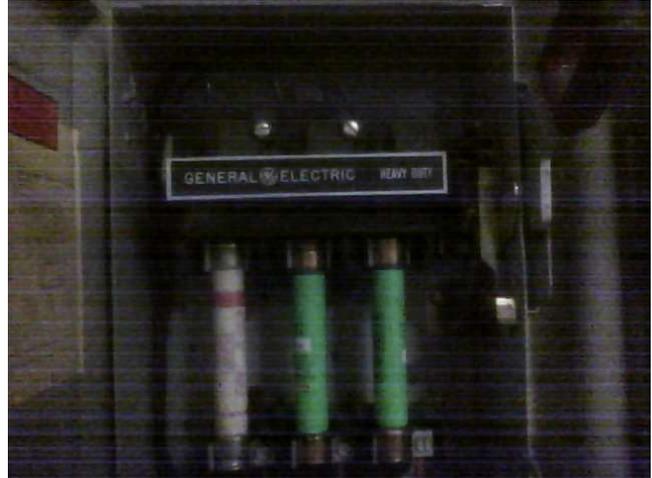
**Location:** Basement Boiler Room  
**BOILER 2**

Target Point	Reference Point	Temperature Difference	Severity: 3-Important
(C) Phase: 135 F	(A) Phase: 123 F	12 F

Target is the (C) phase fuse clip on disconnect.

Further investigation is required to determine the correct repair procedure.

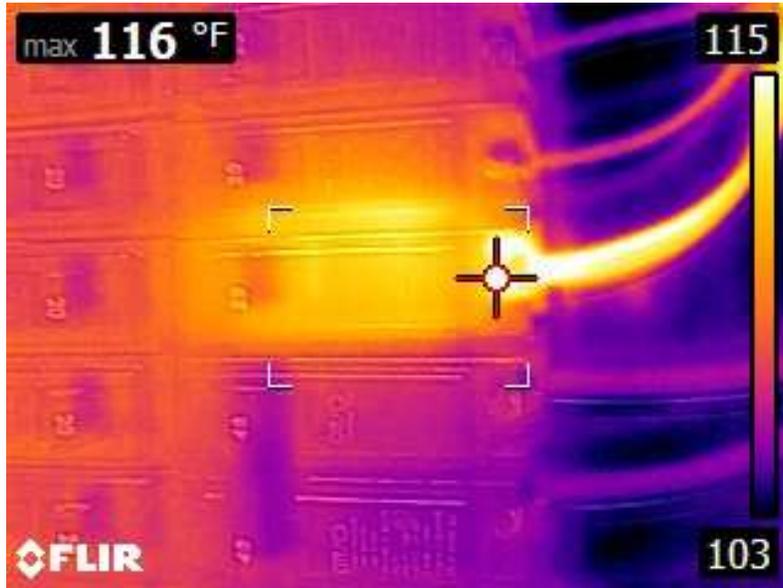
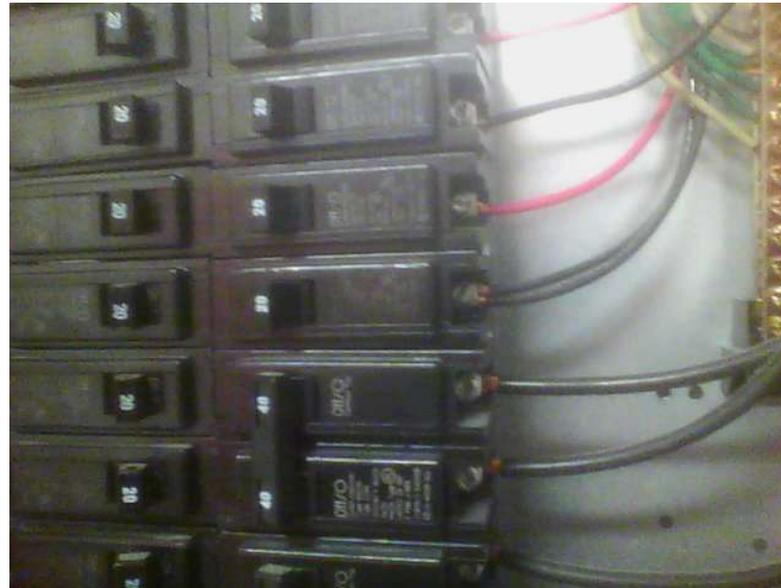
Location/Equipment Information
Asset ID: Branch Panel
Barcode:
Location: Mezzanine Over Office SP1

**Observations:** NEC violation. Multiple circuits to one breaker. Amp draw 16 amps. separate circuits.

**What is the Cause:** Multiple Circuits to One Breaker

**Recommendations:** Make repairs as per the National Electric Code.

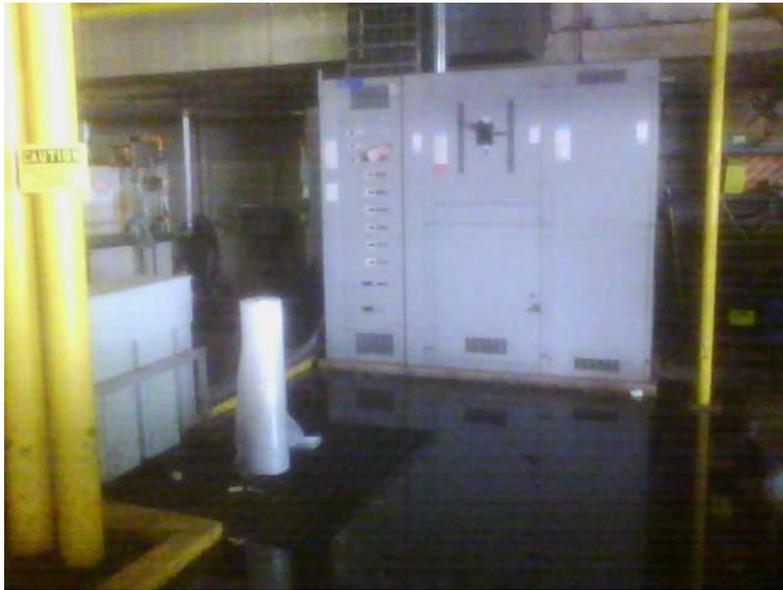
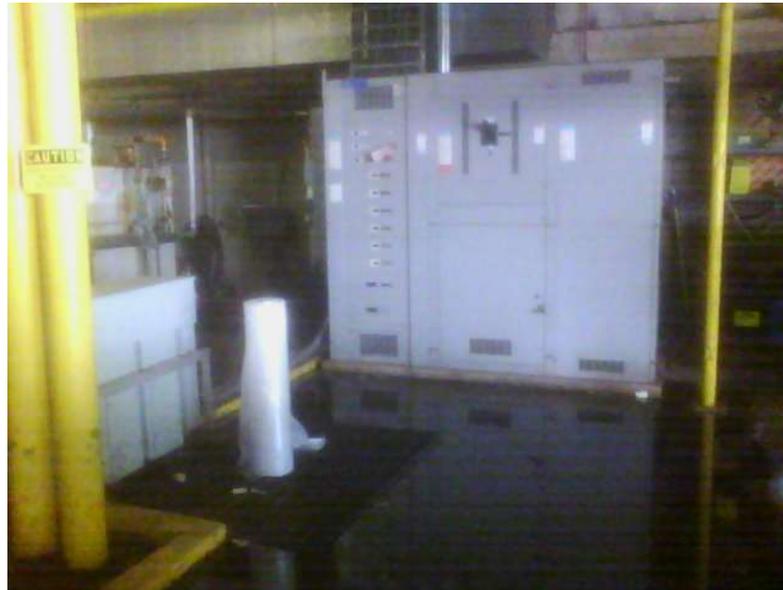
Location/Equipment Information
Asset ID: Switch board
Barcode:
Location: Old Basement NEW SERVICE MAIN

**Observations:** Equipment access obstructed. Water on floor.

**What is the Cause:** Blocked electrical equipment

**Recommendations:** Staff notified.
