DYNA SCAN  
Technical Services

## Infrared Thermographic Inspection

Report Date: 10/26/2017

**Current Inspection No: 4213**  
**Report Date: 10/26/2017**  
**Inspected By : O'Brien, TJ**

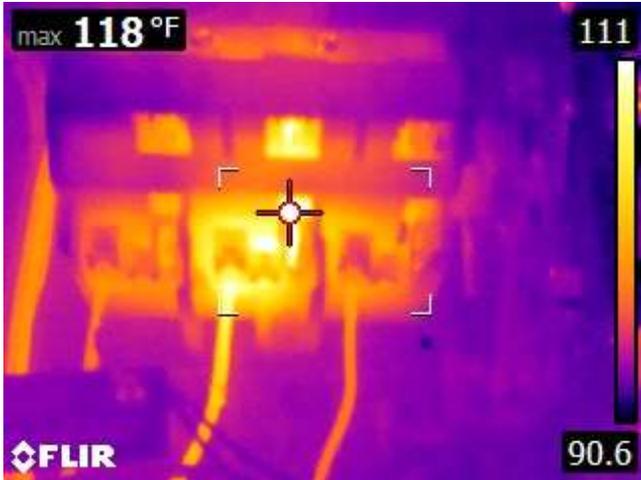
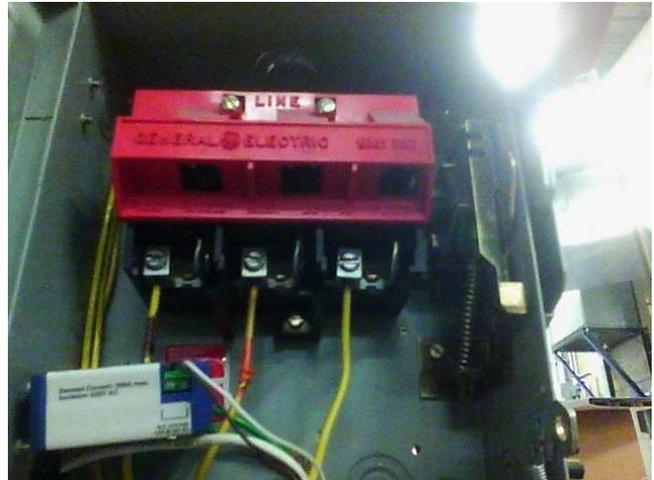
**LOCATION: 71 BUILDING  
LOCATION: BASEMENT  
LOCATION: BOILER ROOM**

Target Point	Reference Point	Temperature Difference	Severity: 3-Important
(B) Phase: 118 F	(C) Phase: 101 F	17 F

Target is the (B) phase knife switch on non-fused disconnect

Shut off power to assembly and inspect knife switch for proper blade tension and alignment. Clean blades thoroughly. Repair or replace parts as necessary.

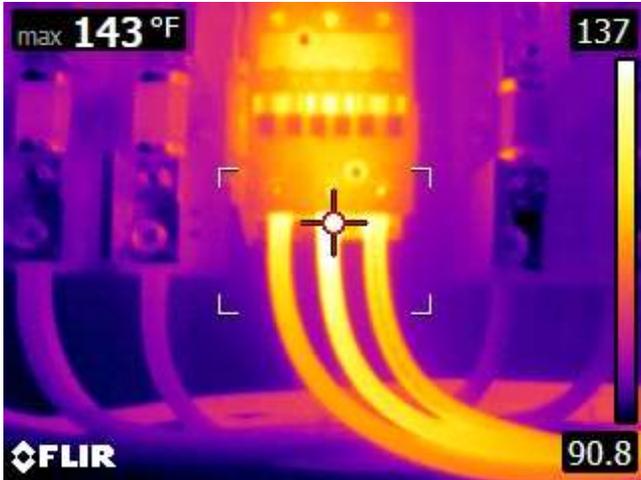
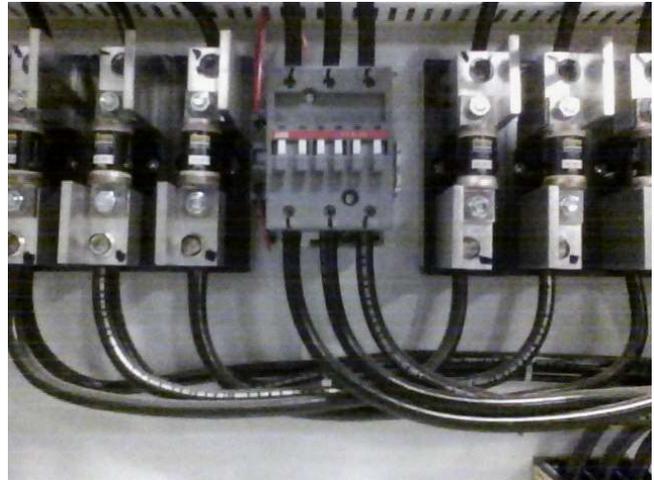
**LOCATION: 71 BUILDING  
LOCATION: BASEMENT  
LOCATION: NEW ELECTRIC ROOM**

Target Point	Reference Point	Temperature Difference	Severity: 3-Important
(B) Phase: 143 F	(C) Phase: 126 F	17 F

Target is the (B) phase, load side connection. Excessive heat on left side contactor

Deenergize and clean, inspect, and torque to specs the target connection

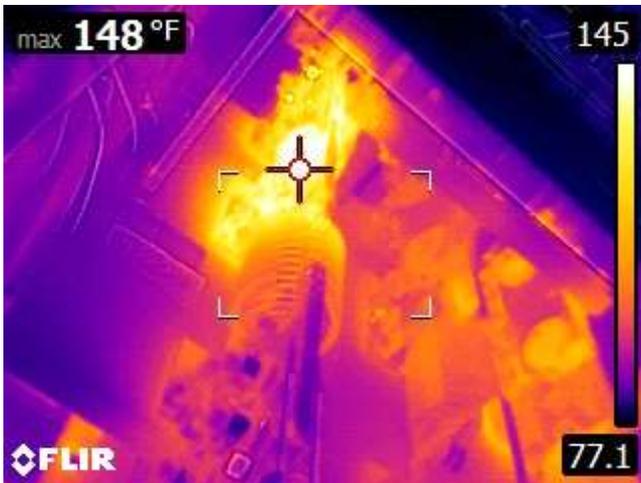
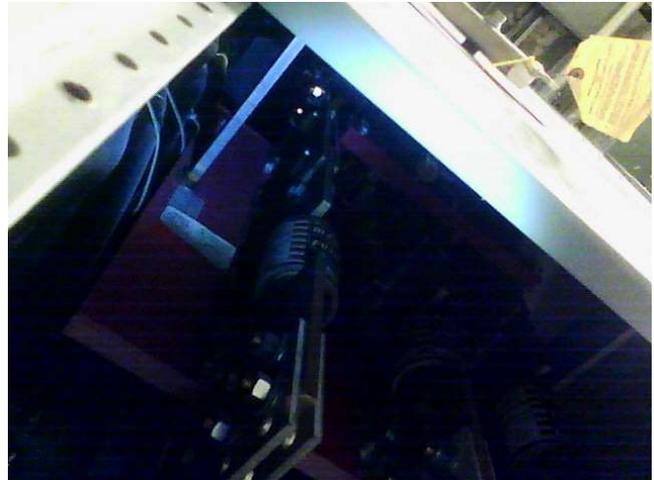
**LOCATION:** 32 BUILDING  
**LOCATION:** BASEMENT  
**LOCATION:** ELECTRIC ROOM

Target Point	Reference Point	Temperature Difference	Severity: 3-Important
(A) Phase: 148 F	(C) Phase: 112 F	36 F

Target is the (A) phase fuse assembly in main switchgear

Further investigation is required to determine the correct repair procedure.

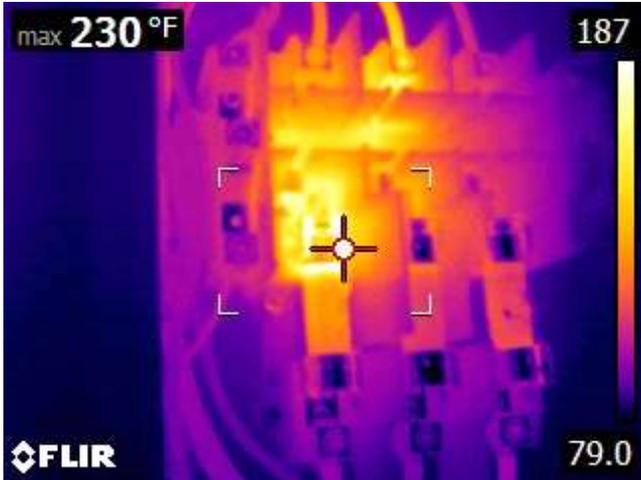
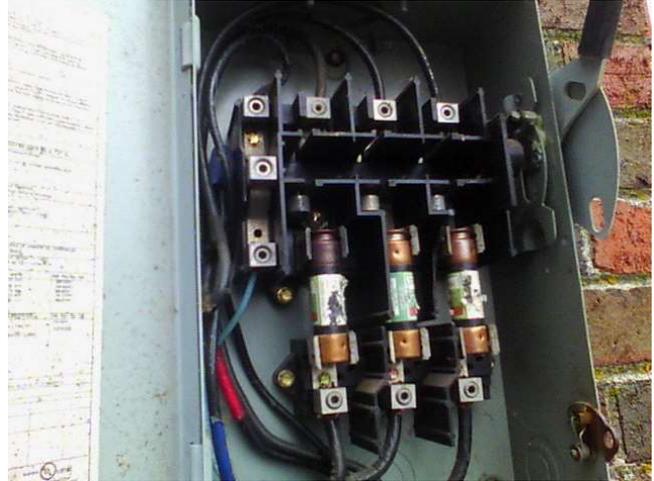
**LOCATION:** 32 BUILDING  
**LOCATION:** 1ST FLOOR  
**LOCATION:** OUTSIDE CAFÉ CHILLER

Target Point	Reference Point	Temperature Difference	Severity: 1-Critical
(A) Phase: 230 F	(C) Phase: 112 F	118 F

Target is the (A) phase, line side, fuse clip on disconnect.  
Note: This is a critical defect. Staff was notified on-site

Due to intense heat located at target area, un-repairable damage has likely occurred to equipment components. Recommend replacing all components associated with this defect. After fix, check with spot gun to insure a successful repair.

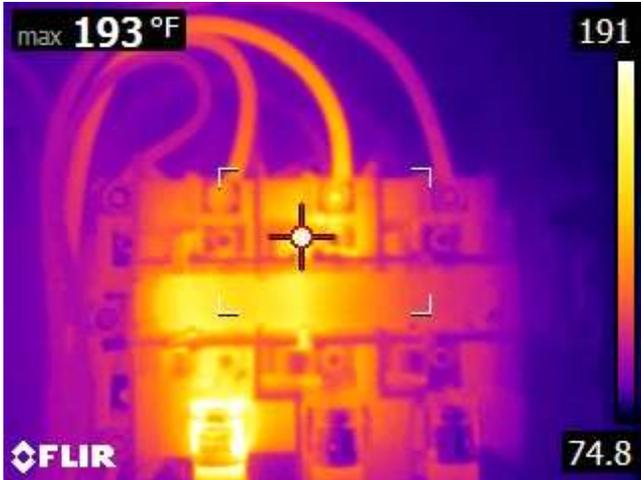
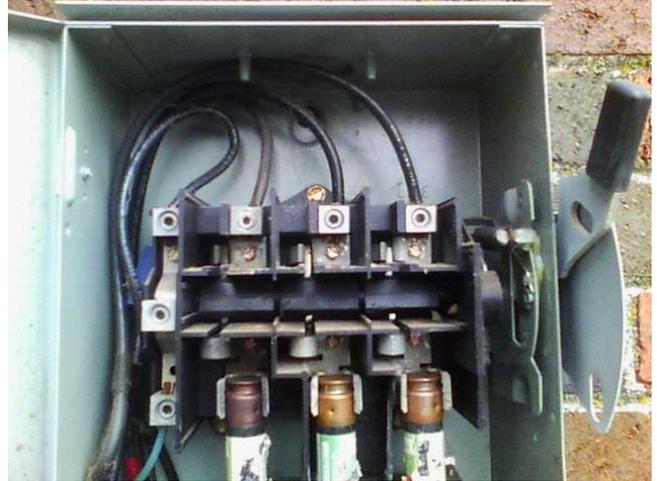
**LOCATION:** 32 BUILDING  
**LOCATION:** 1ST FLOOR  
**LOCATION:** OUTSIDE CAFÉ CHILLER

Target Point	Reference Point	Temperature Difference	Severity: 1-Critical
(B) Phase: 193 F	(C) Phase: 105 F	88 F

Target is the (B) phase knife switch on disconnect. Note: This is a critical defect. Staff was notified on-site

Intense heat has likely caused damage to target. Recommend replacement of kniveswitch

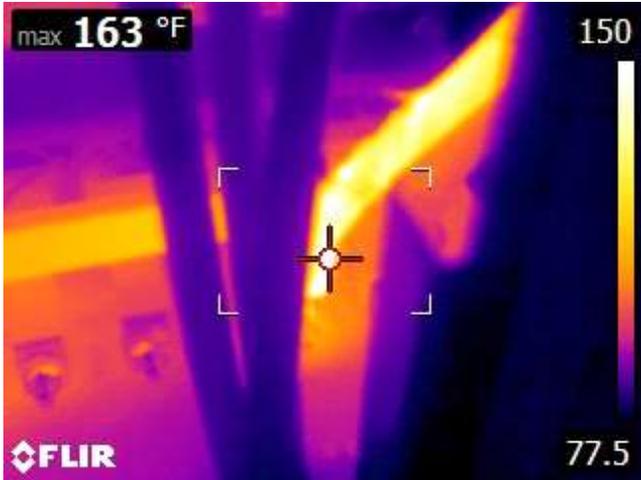
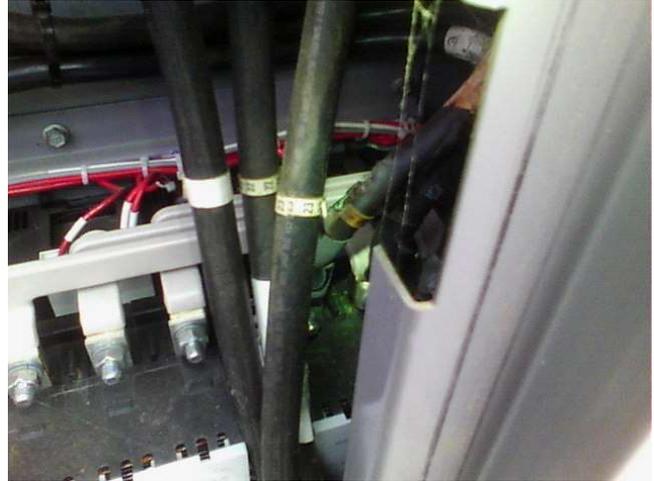
**LOCATION: HANSON CENTER  
LOCATION: OUTSIDE CHILLER  
Chiller**

Target Point	Reference Point	Temperature Difference	Severity: 1-Critical
(A) Phase: 163 F	(C) Phase: 102 F	61 F

Target is the (A) phase, load side contactor labeled "1M."  
NOTE: This is a critical defect. Staff was notified about issue while on site

Further investigation is required to determine the correct repair procedure.

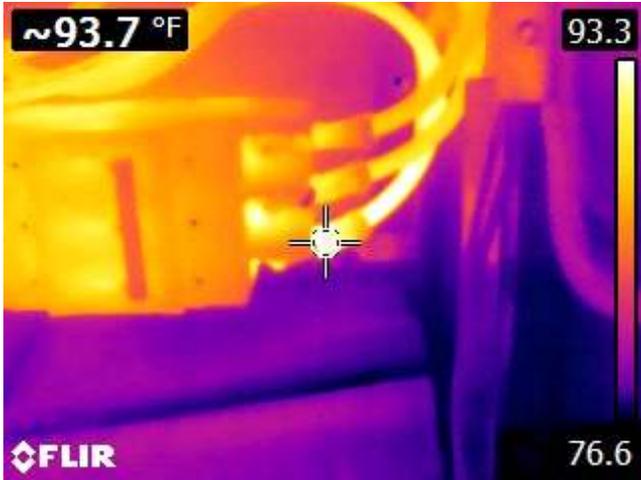
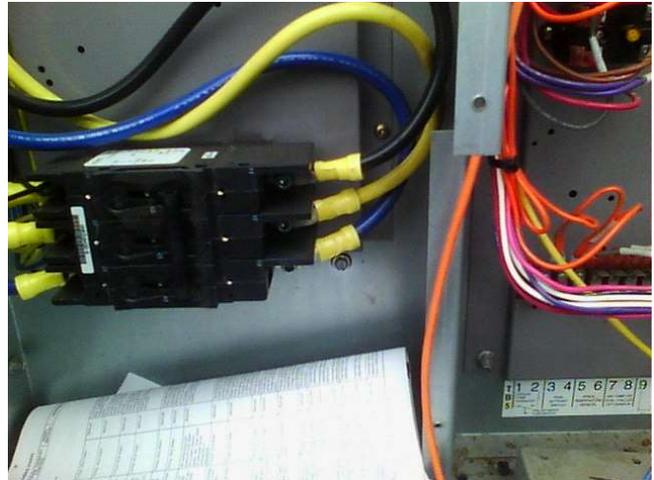
**LOCATION: HANSON CENTER  
LOCATION: OUTSIDE CHILLER  
Chiller**

Target Point	Reference Point	Temperature Difference	Severity: 3-Important
(C) Phase: 94 F	(A) Phase: 82 F	12 F

Target is the (C) phase, line side, connection defect on 63 amp breaker. Amperage reading was not obtained during time of inspection

Deenergize and clean, inspect, and torque to specs the target connections

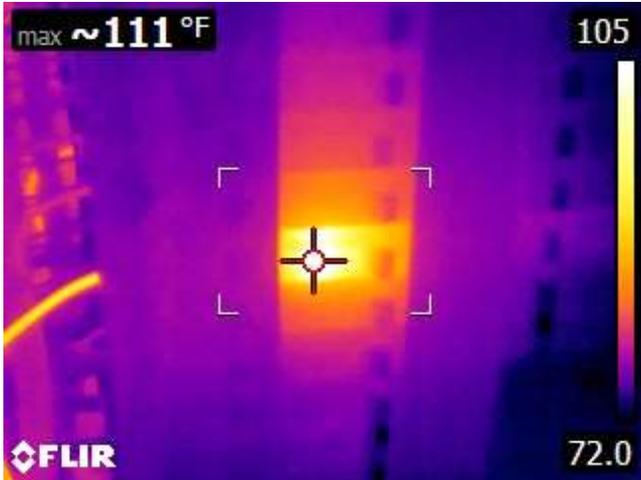
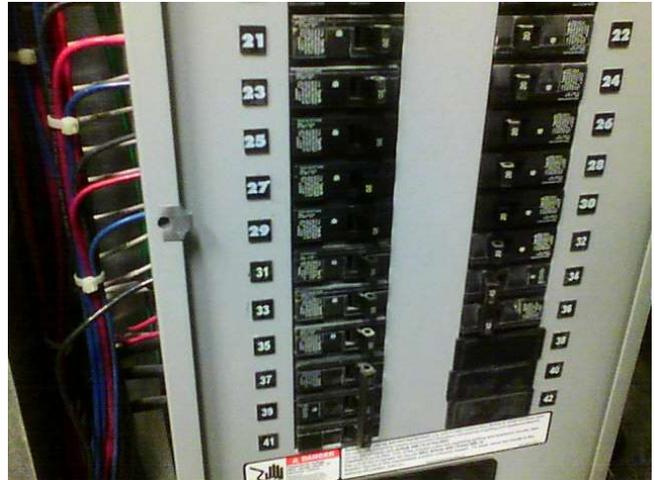
**LOCATION: HANSON CENTER  
LOCATION: 1ST FLOOR  
LOCATION: ELECTRIC CLOSET**

Target Point	Reference Point	Temperature Difference	Severity: 3-Important
Breaker #31: 111 F	Breaker #36: 73 F	38 F

Target is breaker #31, possible overload on 30 amp breaker. Feeds "Neon Sign"

Further investigation is required to determine the correct repair procedure.

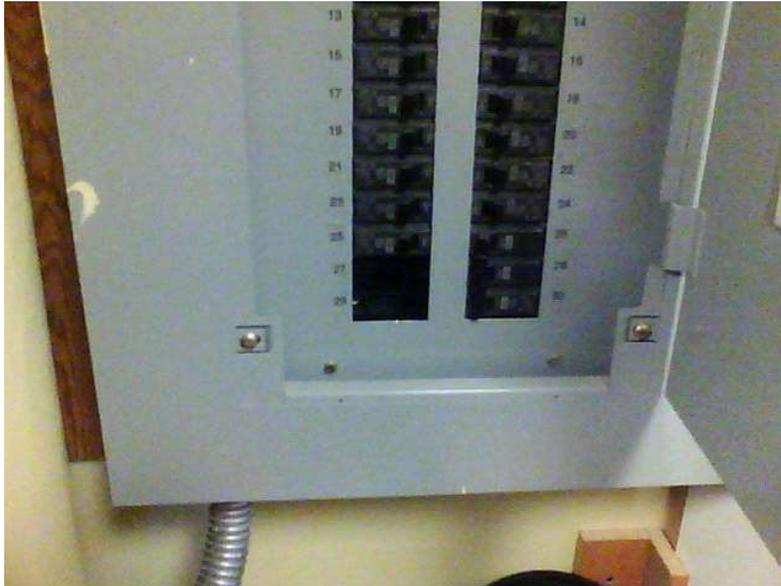
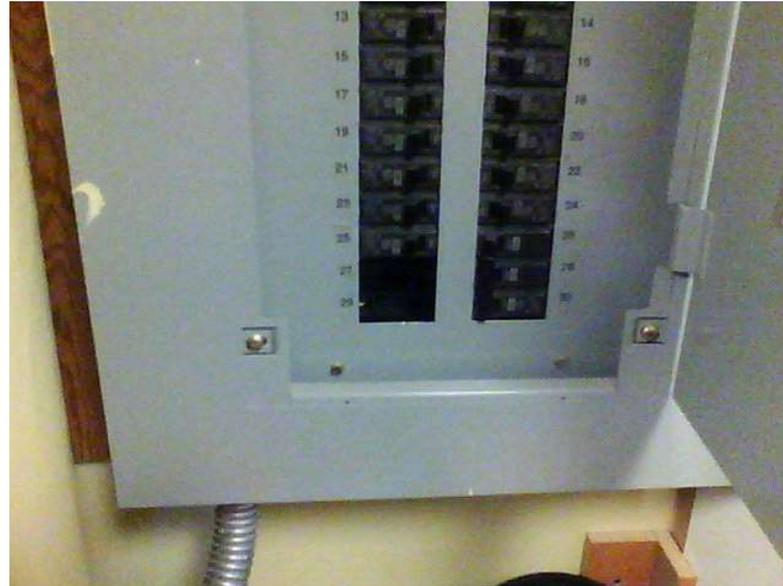
Location/Equipment Information
Asset ID: Branch Panel
Barcode:
LOCATION: 32 BUILDING
LOCATION: 3RD FLOOR
LOCATION: SLEEP LAB
BLLS 3

**Hazard Issue:** Enclosure not sealed properly, this voids the UL listing.

**Observations:** A number of branch panels were observed missing breaker slots. These enclosures not sealed properly, and thus voids the UL listing. This is also an NEC violation. Other panels include, but not limited to: Pnl #40 (outside chiller area), Pnl #34 (Doctor bathroom)

**Consequences of Hazard:** Unwanted entry of foreign objects into panel; Injury or death caused by contact to energized components

**What is the Cause:** Missing Breaker Slot Covers

**Recommendations:** Repair as per the National Electric Code
